**Assessment of Damage to
Residential Buildings
Caused by the
Northridge Earthquake**

July 30, 1994

**NAHB Research Center
Upper Marlboro, Maryland**

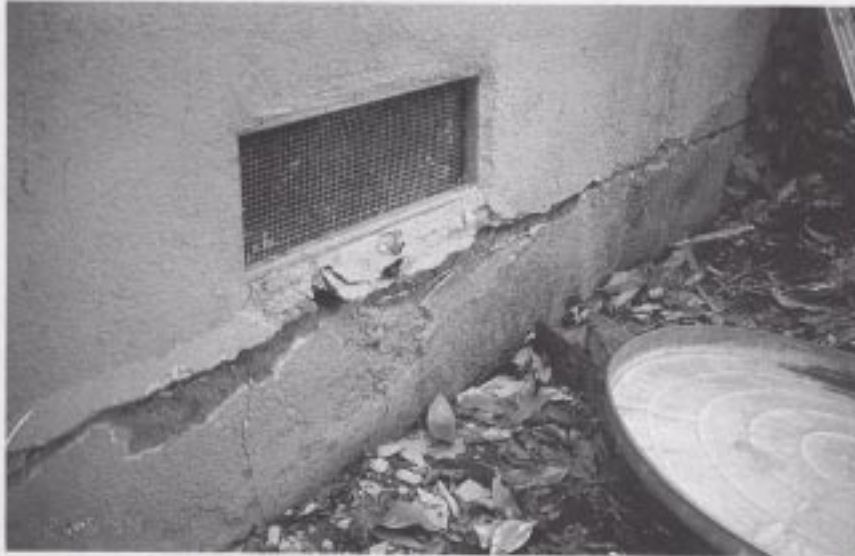
Figure 7. Photograph showing an example of "HIGH" damage to the foundation-wall/floor connection on the crawlspace foundation in a SFD home.

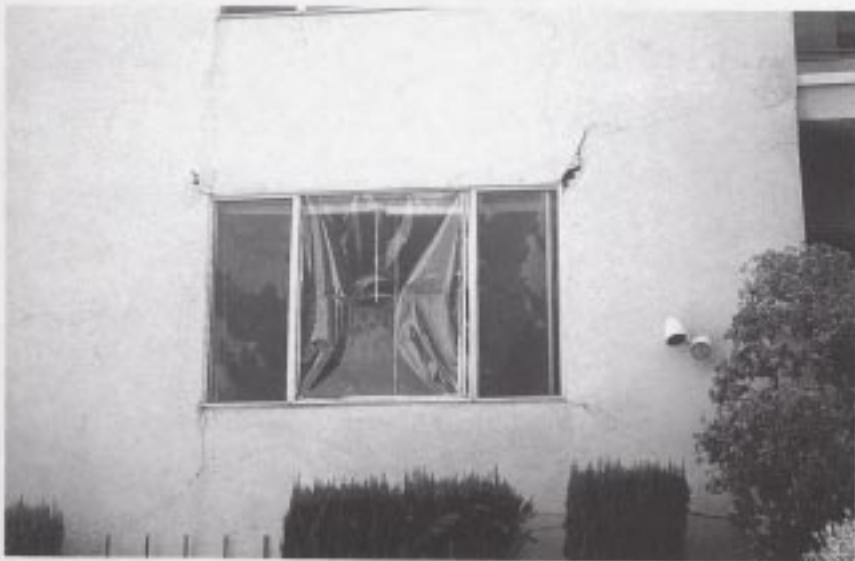
Figure 8. Photograph of a MFLR building with "MODERATE" damage to the First Story-Exterior Wall Finish (stucco) of a MFLR building.

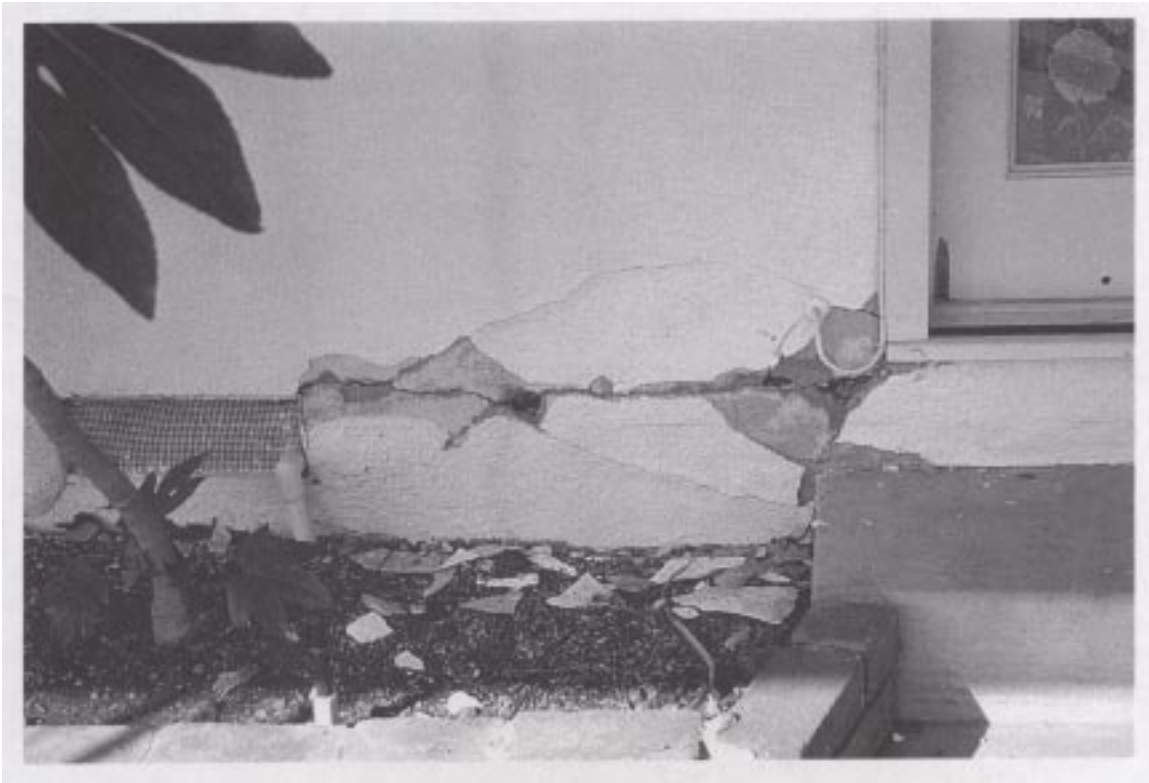
Figure 15. Stucco damage along the top of a crawlspace foundation on a SFD home.

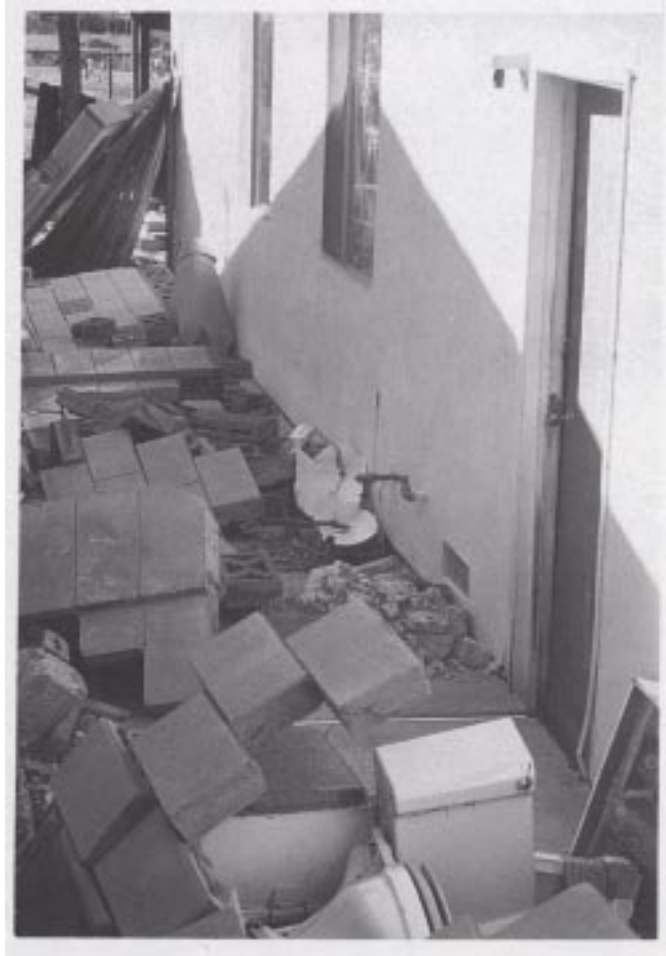
Figure 17. An example of one home in Simi Valley which experienced settlement because of soil liquefaction. (Foundation damage rating: HIGH)

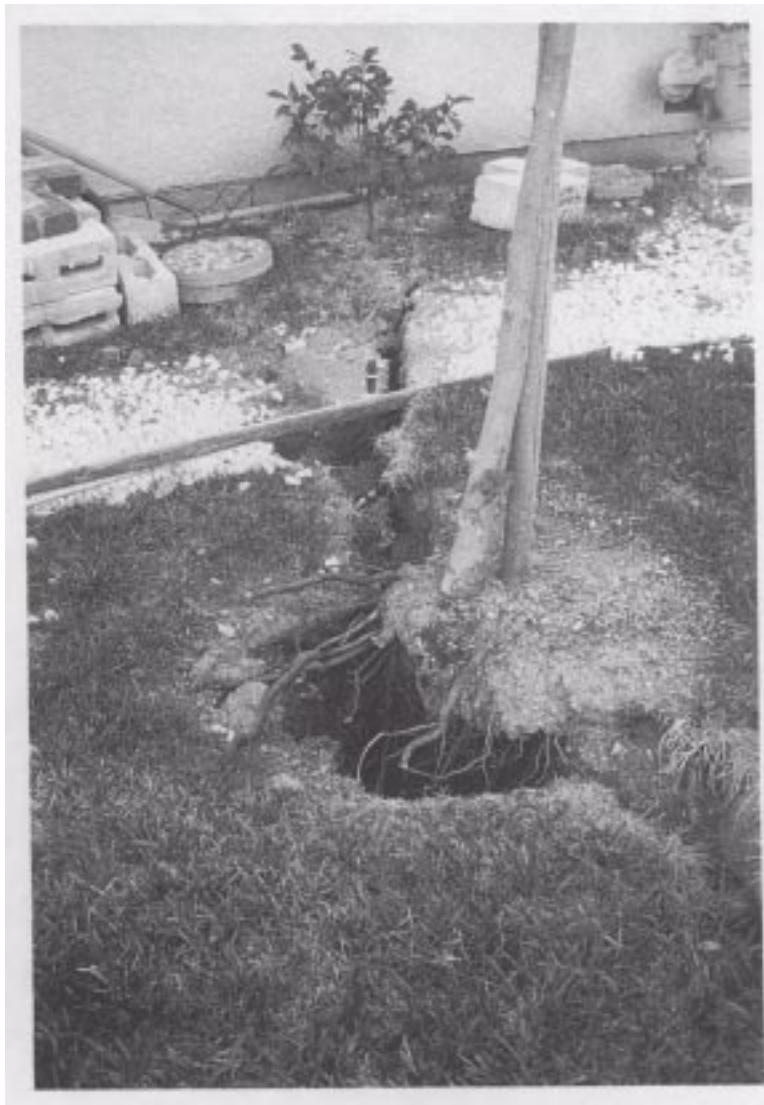
Figure 18. An example of a ground fissure intersecting the foundation of a home located in the Tujunga Canyon area.

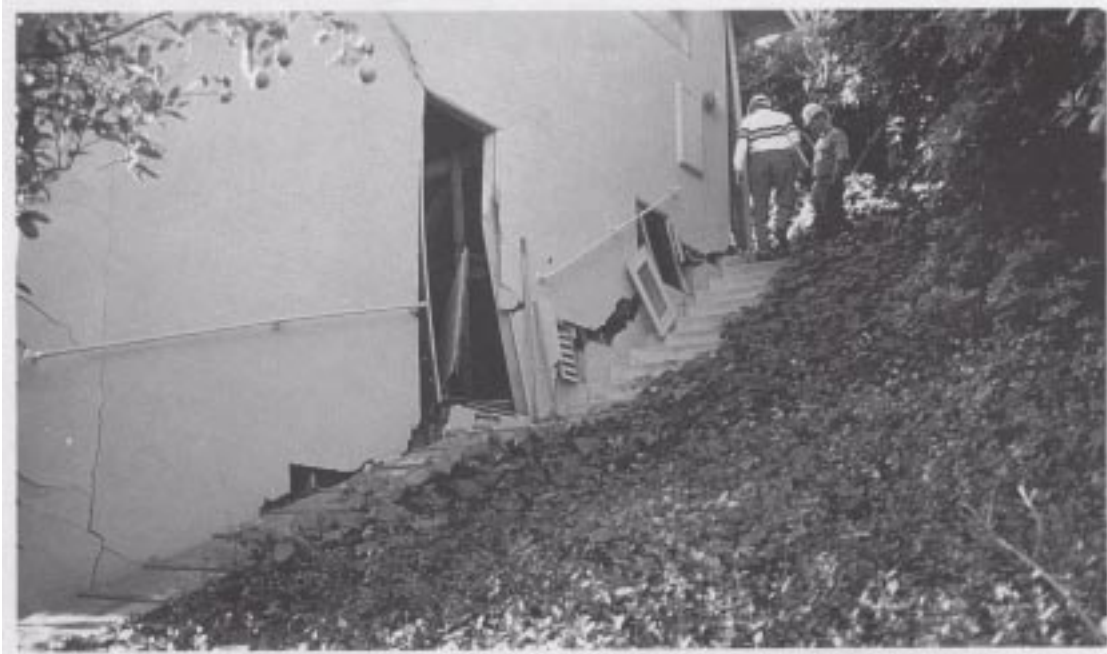
Figure 19. One example of the serious nature of foundation damage on hillside homes with a stepped foundation wall (Foundation/wall connection damage rating: HIGH)

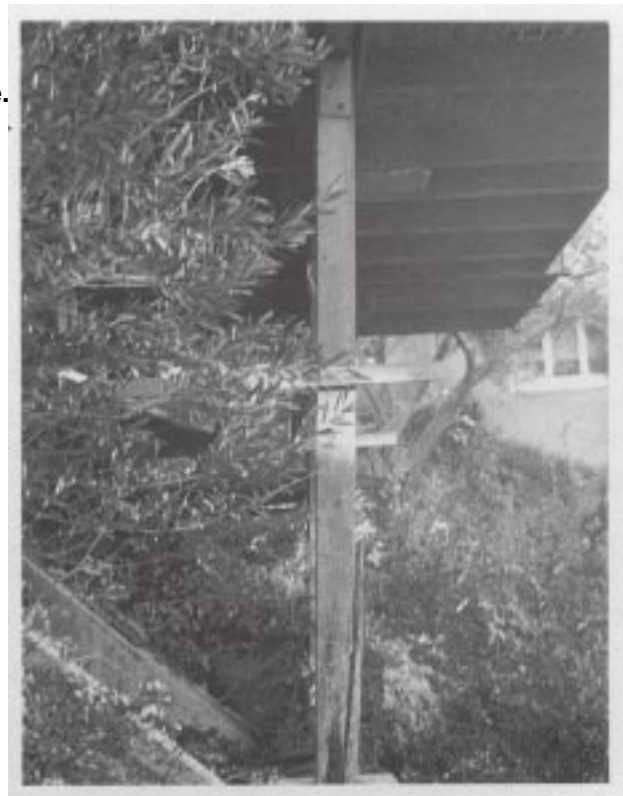
Figure 20. Splintered and leaning, the 6x6 wood columns were marginally successful in supporting this home which overhangs a hill-side. (Foundation damage rating: HIGH)

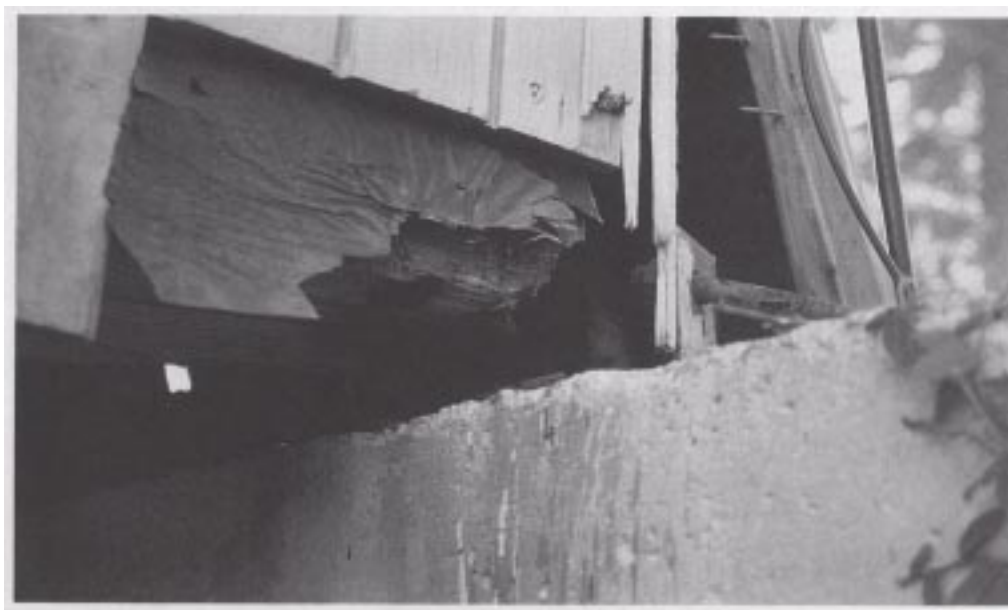
Figure 21. Example of a critical failure at the connection of the floor joists to the foundation wall on the same home as in Figure 20. (Foundation/wall connection rating: HIGH)

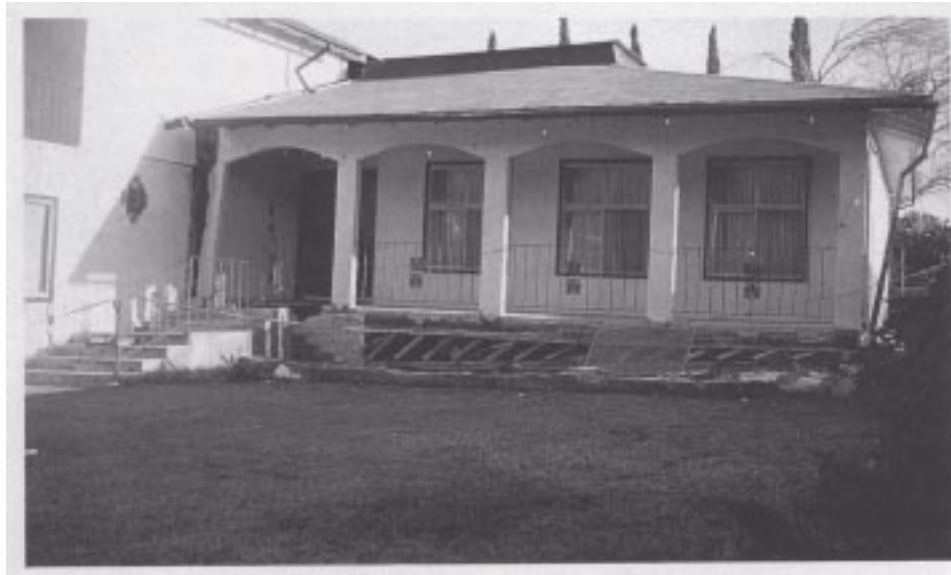
Figure 22. An example of a foundation collapse of the section of a home supported on a cripple wall caused by the 1994 Northridge Earthquake.

It is well-known that improperly braced foundation cripple walls are highly susceptible to racking as shown in Figure 22 above. While the walls of this home were reinforced following damage from the 1971 (Figure 23) earthquake, the need to reinforce the cripple wall was apparently overlooked (Figure 22). Also, discontinuity in foundation type under this home may have contributed to the damage.

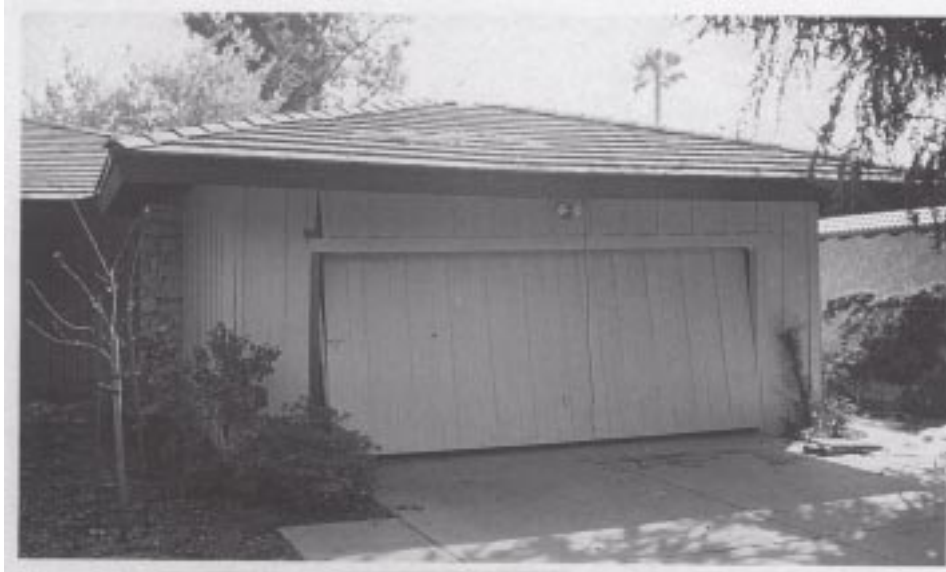
Figure 24. An example of wall racking resulting in damage to a garage door opening. (Wall damage rating: HIGH)

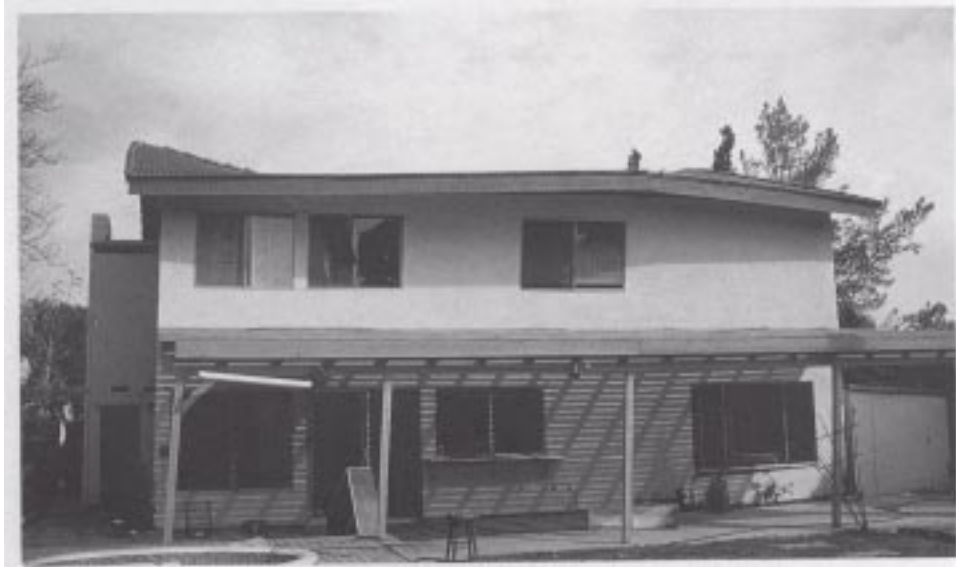
Figure 25. An example of severe roof damage on an overloaded gable-roof with heavy tile roofing. (Roof damage rating: HIGH)

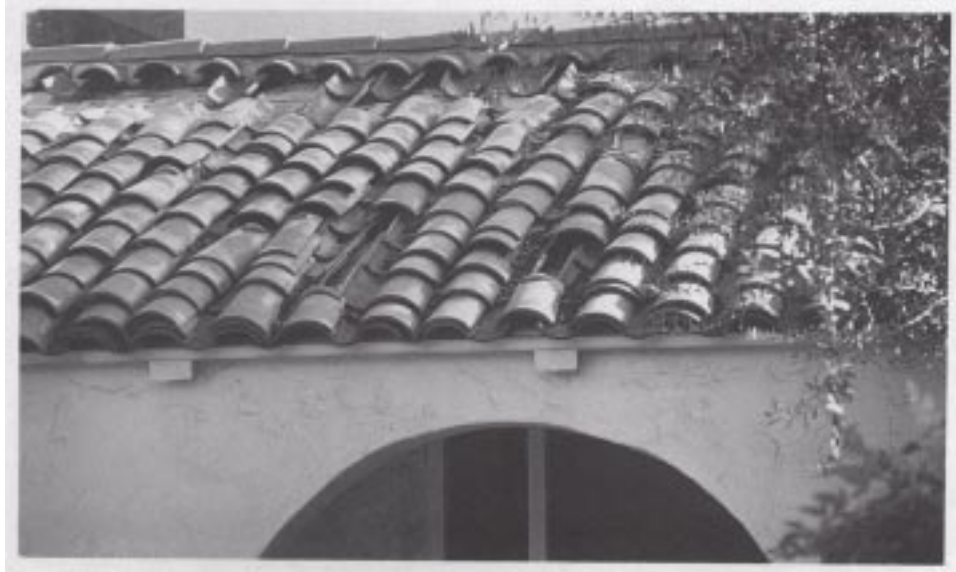
Figure 26. An example of dislodged roof tiles caused by ground shaking and poor attachment.

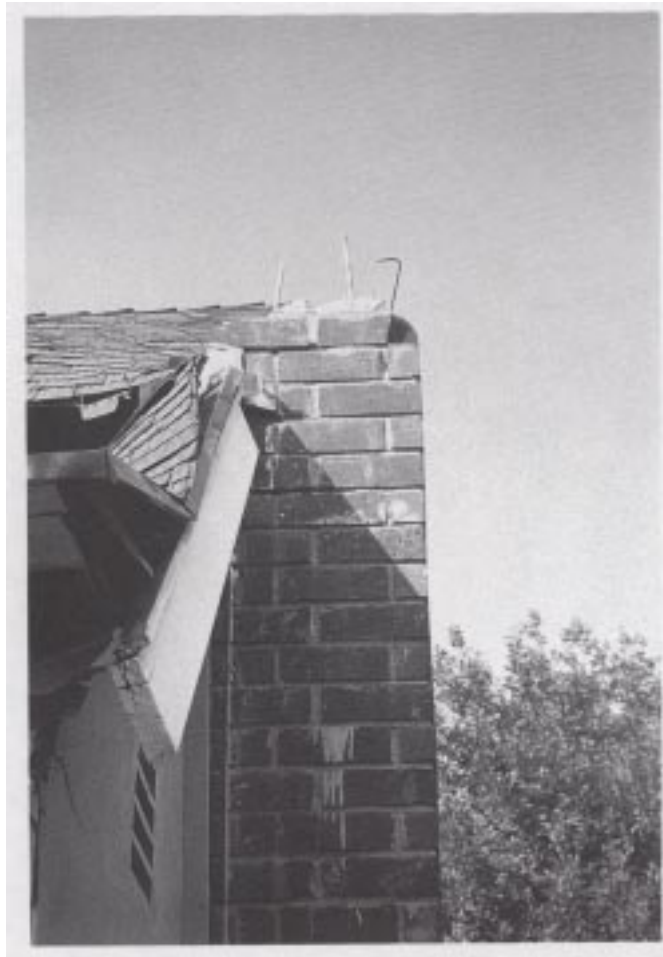
Figure 27. An example of damage to masonry chimneys and the surrounding roof framing.

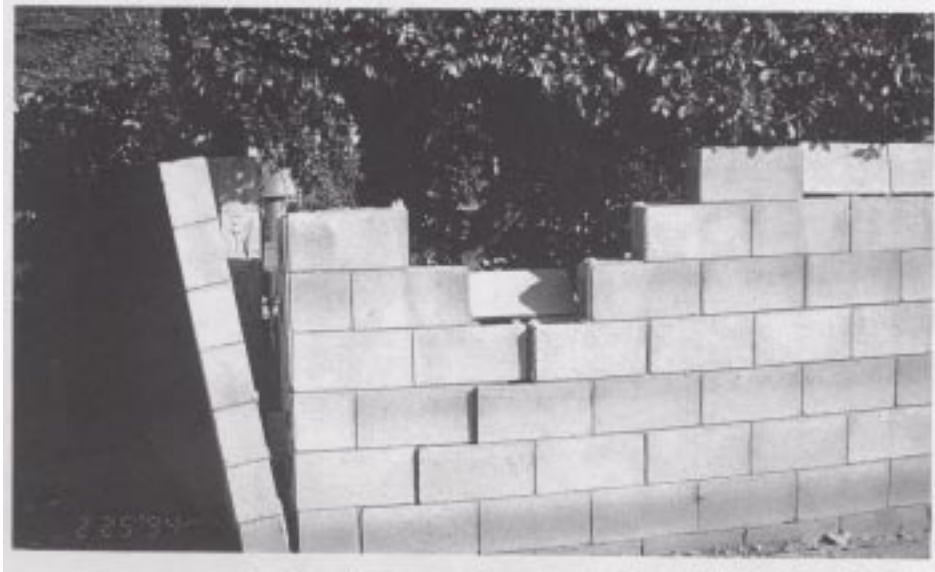
Figure 28. An example of common damage to masonry privacy walls or fences.

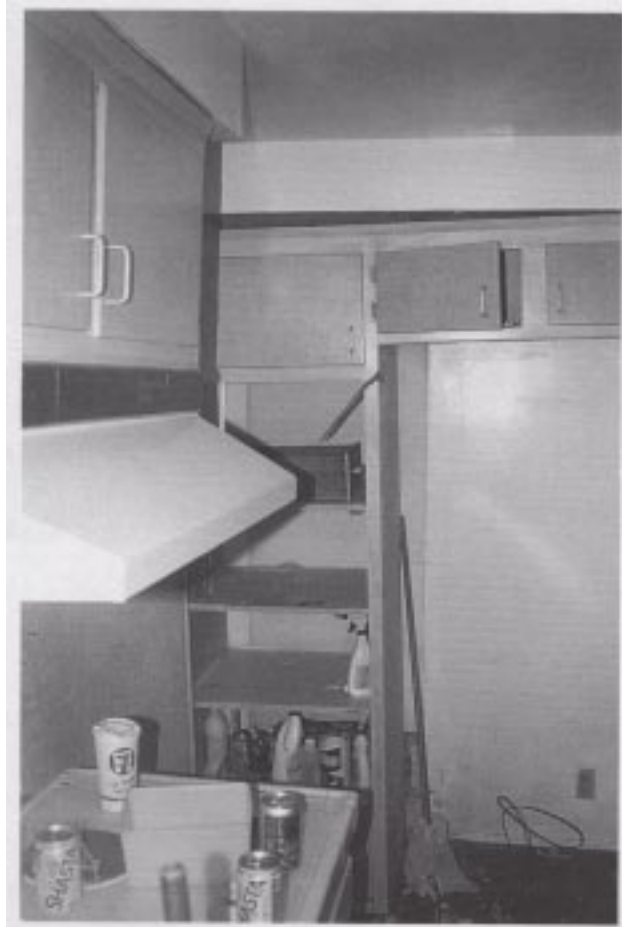
Figure 29. An example of damage to shelves and cabinets in the kitchen of one home.

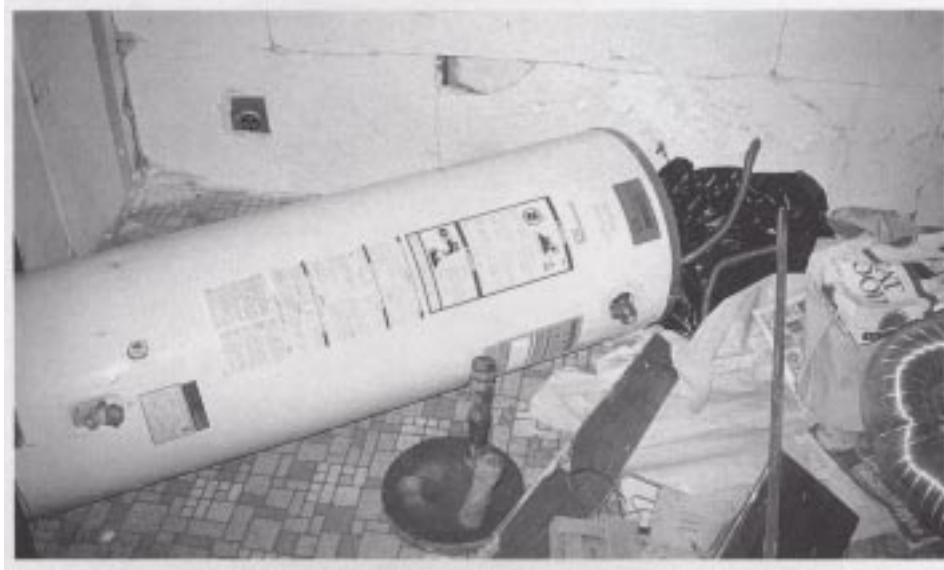
Figure 30. An example of frequent damage to water heaters.

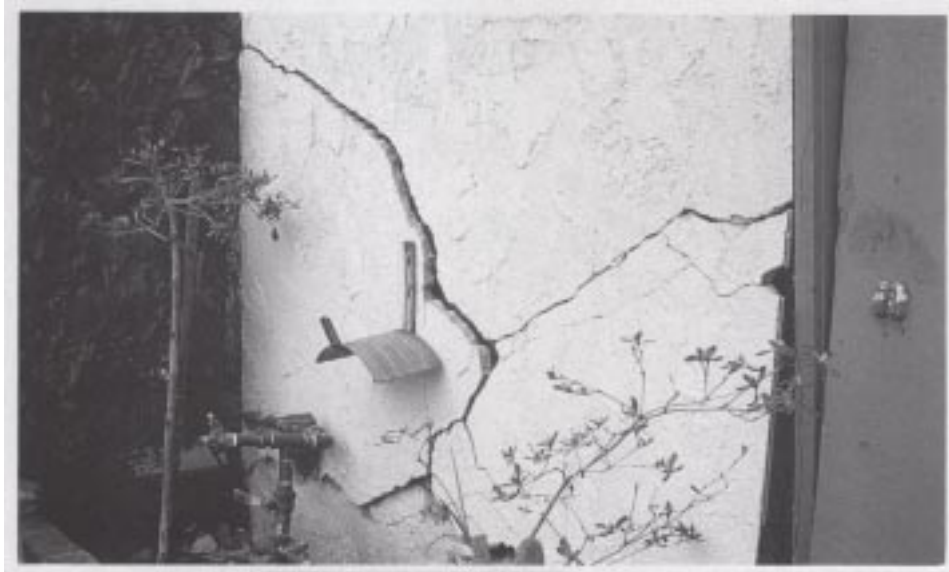
Figure 31. An example of severe stucco damage.

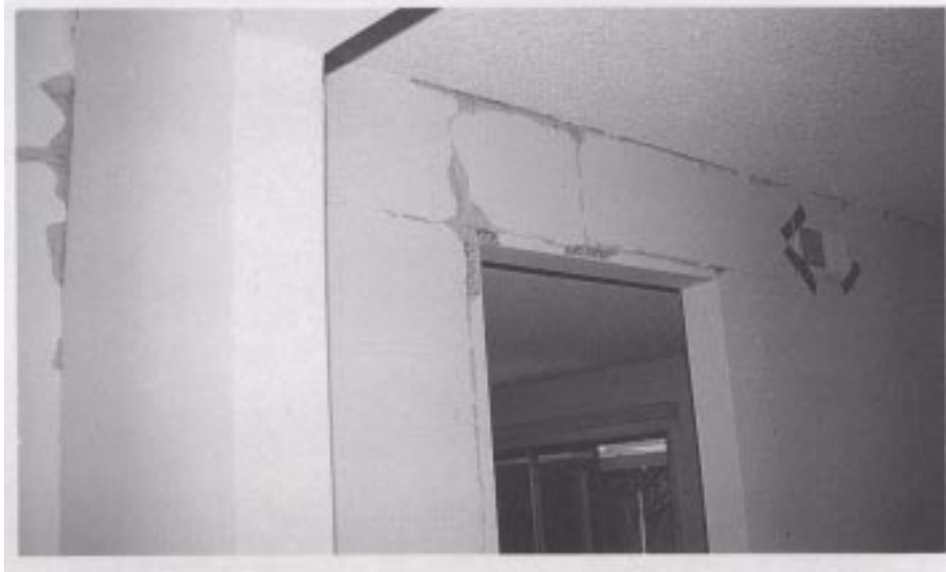
Figure 32. An example of severe (“HIGH”) interior finish damage (gypsum board) at partition wall intersections and openings in the walls.

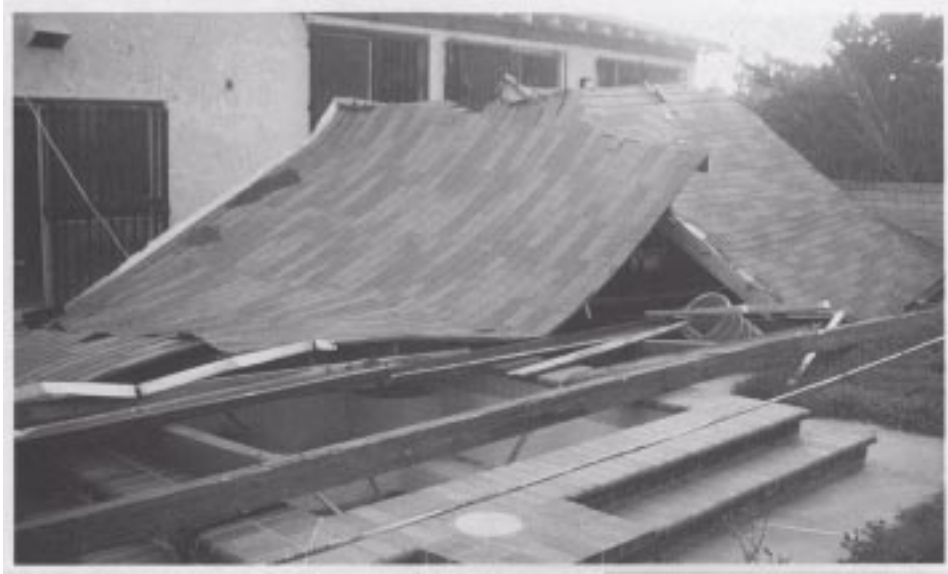
Figure 33. An infrequent collapse of a porch attached to a home.

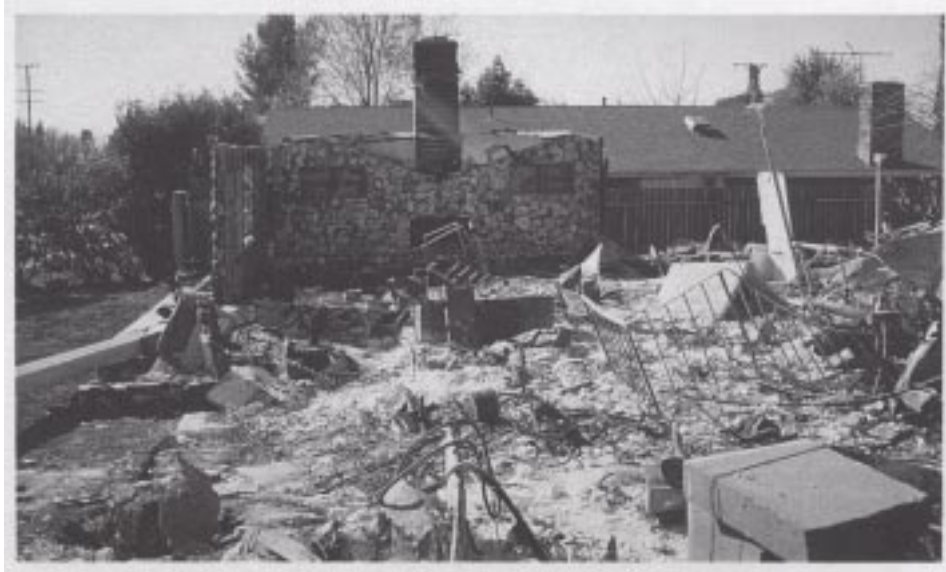
Figure 34. An example of the rare occurrence of fire damage resulting from ignited gas leaks caused by the earthquake.

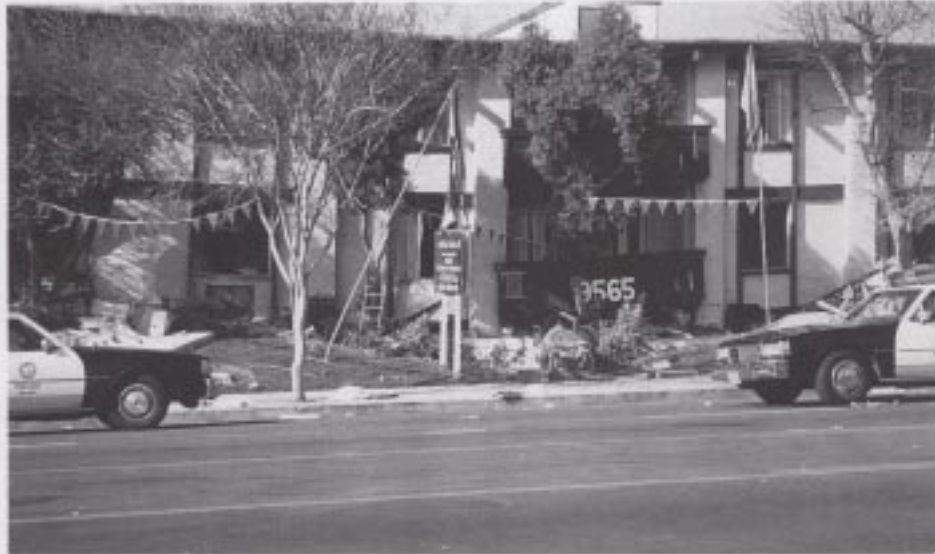
Figure 40. The Northridge Meadows collapse where 16 lives were lost in dwelling units located on the crushed soft story of this MFLR building.

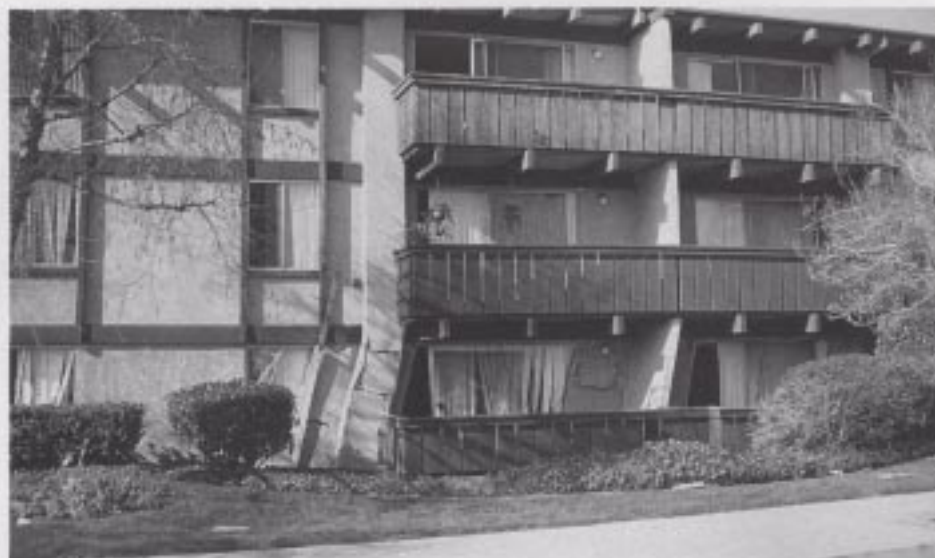
Figure 41. Another section of the Northridge Meadows MFLR building where the soft story is severely racked, but not collapsed.

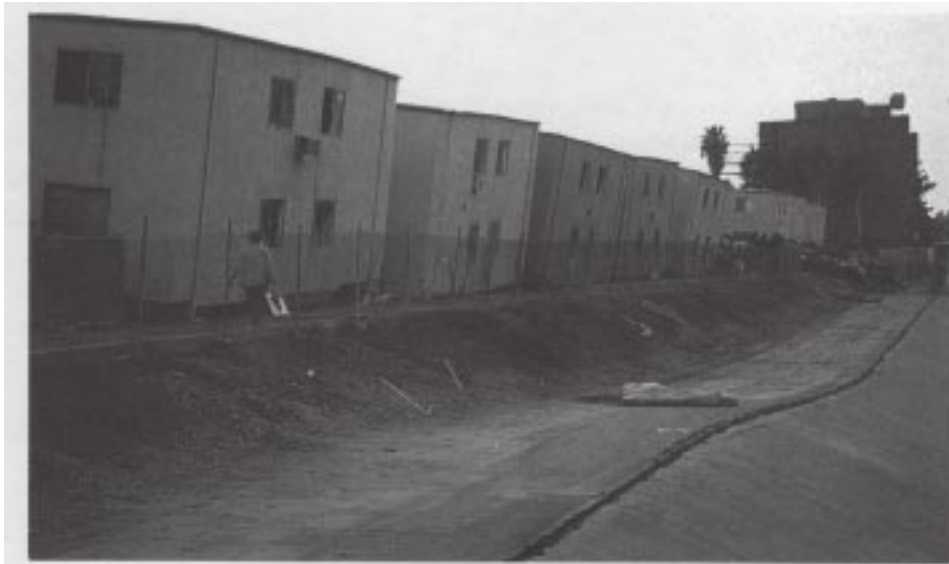
Figure 42. A soft-story collapse of MFLR buildings on Victory Boulevard Dwelling units were not located at the garage or soft-story level in this case.

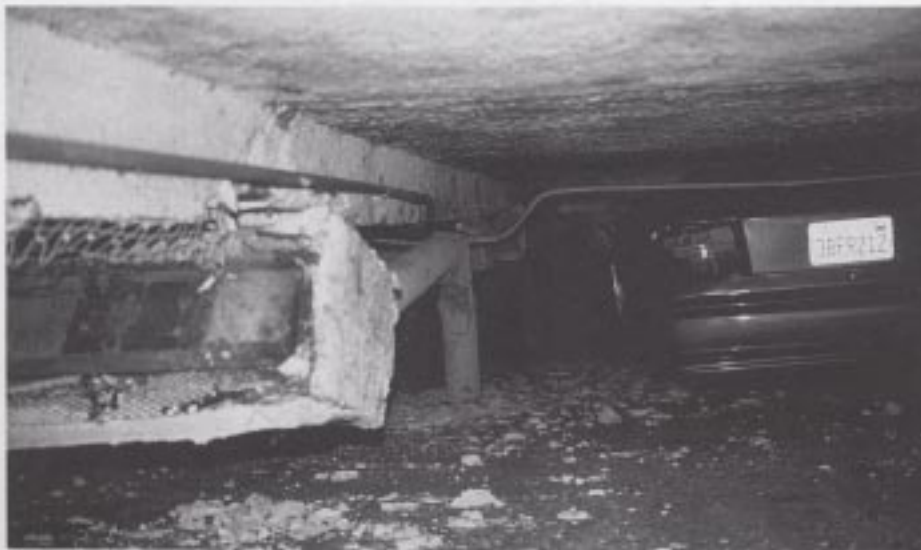
Figure 43. A view beneath the Victory Boulevard MFLR building collapse showing the bent steel pipe column and a crushed vehicle.

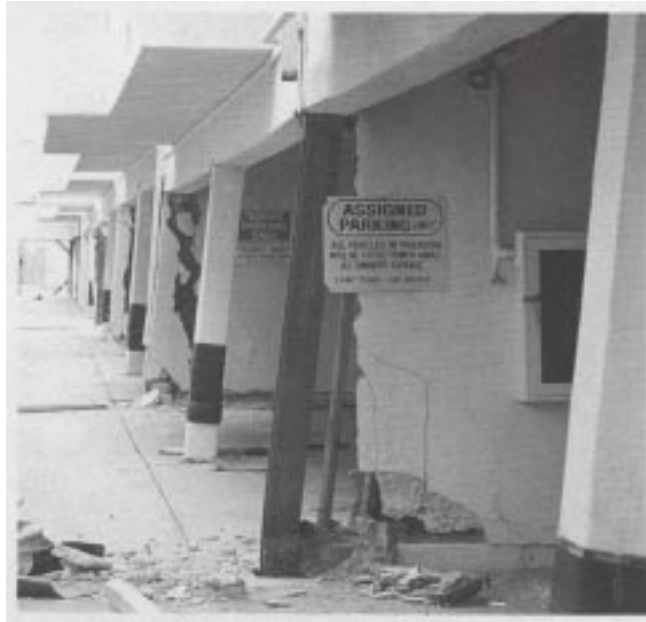
Figure 44. An example of severe deflection of a steel column and stucco shear wall of soft-story MFLR construction.

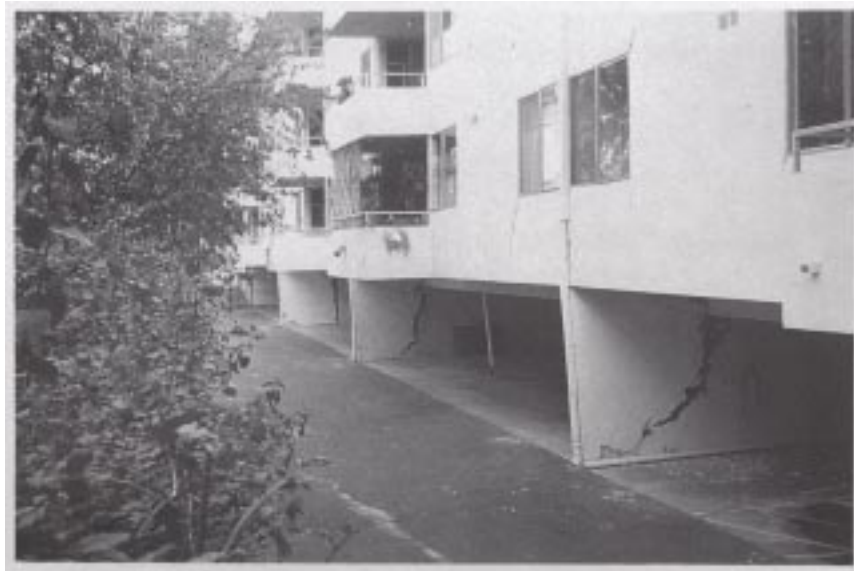
Figure 45. Failure and diagonal cracking of a wood-frame and stucco shear wall used in this soft-story MFLR construction.

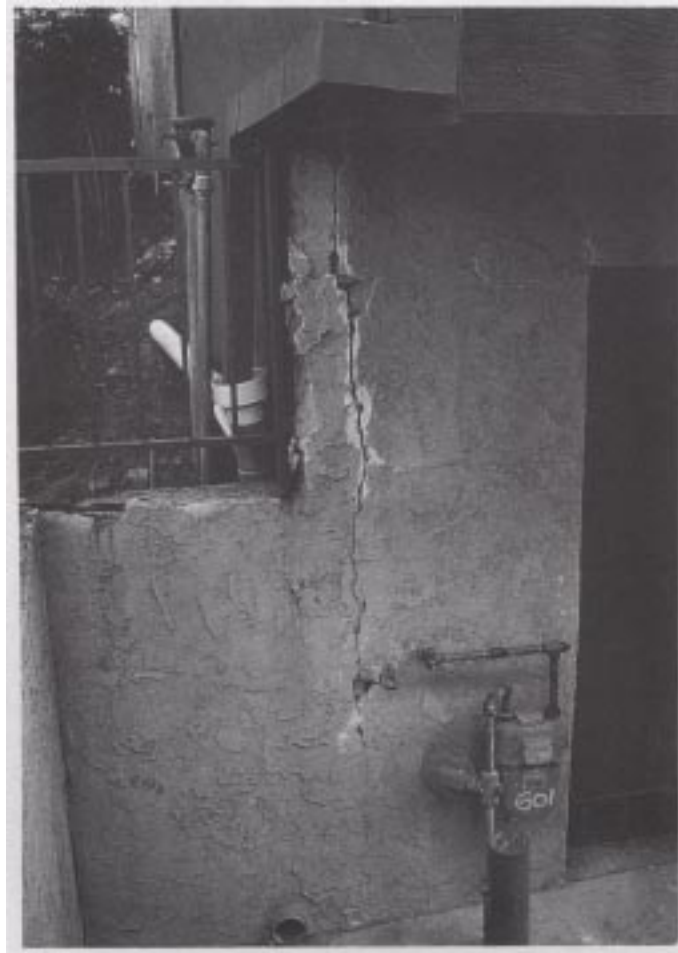
Figure 46. Racking of wood-frame and stucco walls along the garage openings of a SFA building.

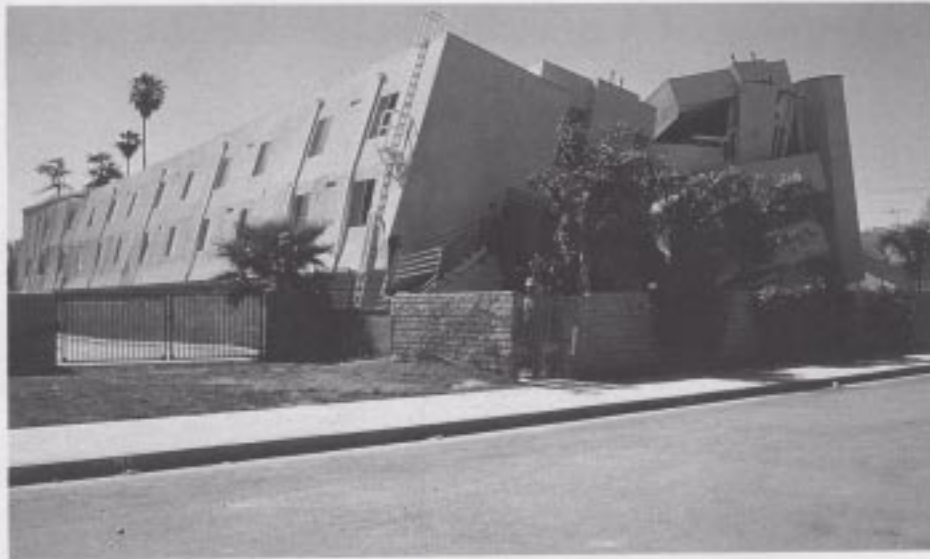
Figure 47. A new (1988 vintage) MFLR building on Sherman Way with a rare collapse of a reinforced concrete and masonry garage foundation.

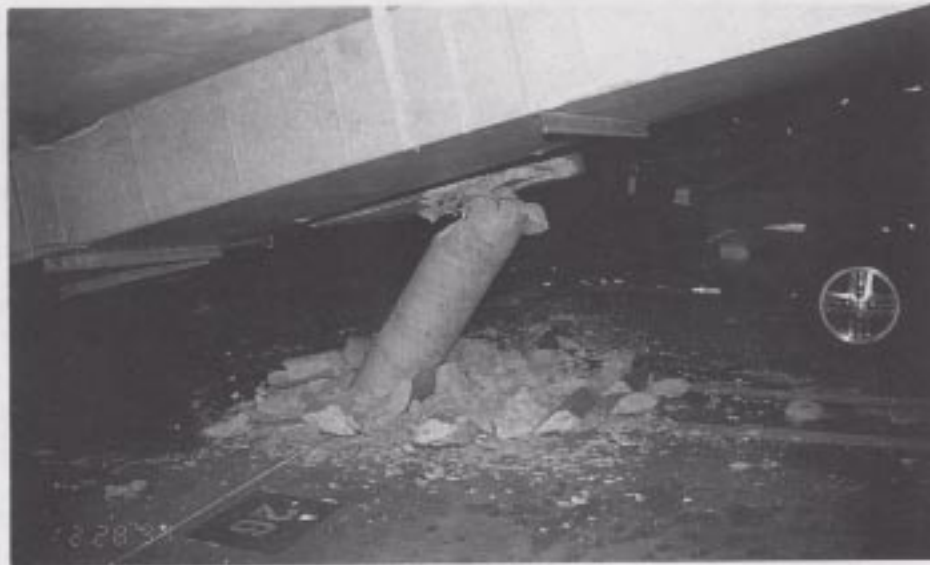
Figure 48. A view inside the collapsed garage showing a small, telescoped concrete column crushed by the weight of a thick concrete slab and added inertial load from potentially high vertical ground acceleration.

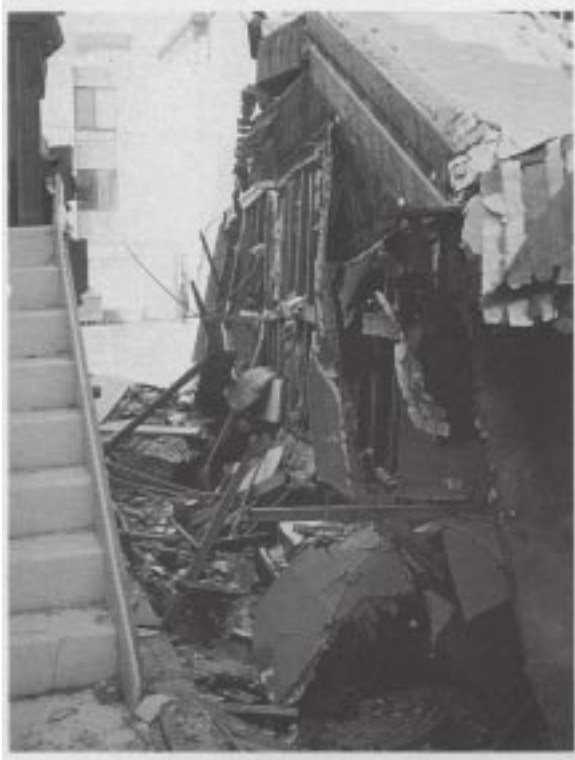
Figure 49. Separation and collapse of a soft-story garage area (right side) once connected to the unmoved portion supported by a slab-on-grade foundation (left side).

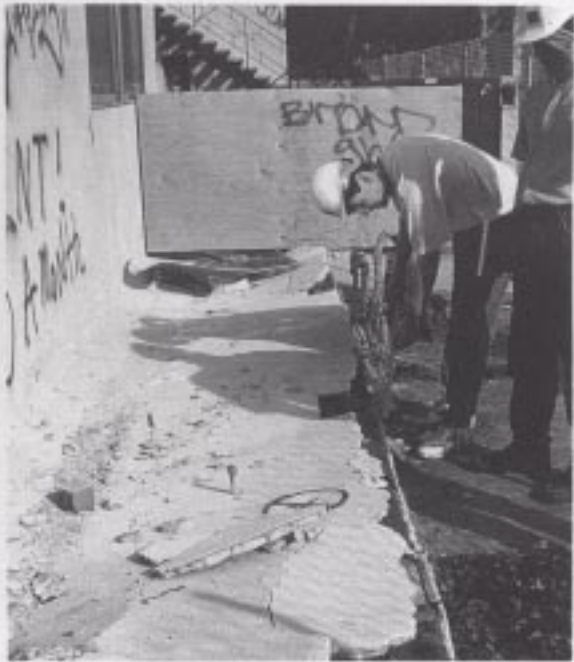
Figure 50. Collapse of a cripple-wall foundation connected to a collapsed soft-story garage on Mammoth Avenue.

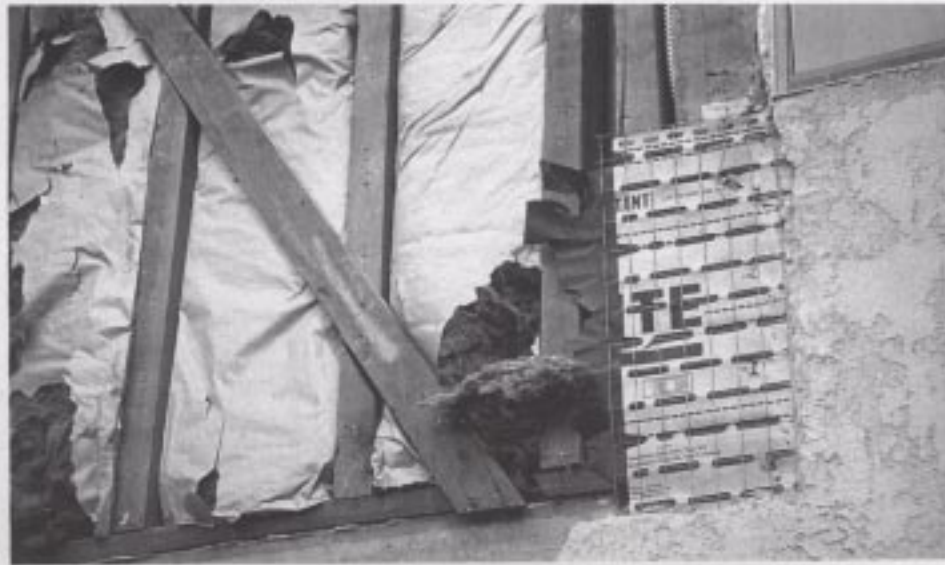
Figure 51. A damaged stucco and wood-frame wall under repair showing 3x framing and a 1x let-in brace disconnected from the sill plate.

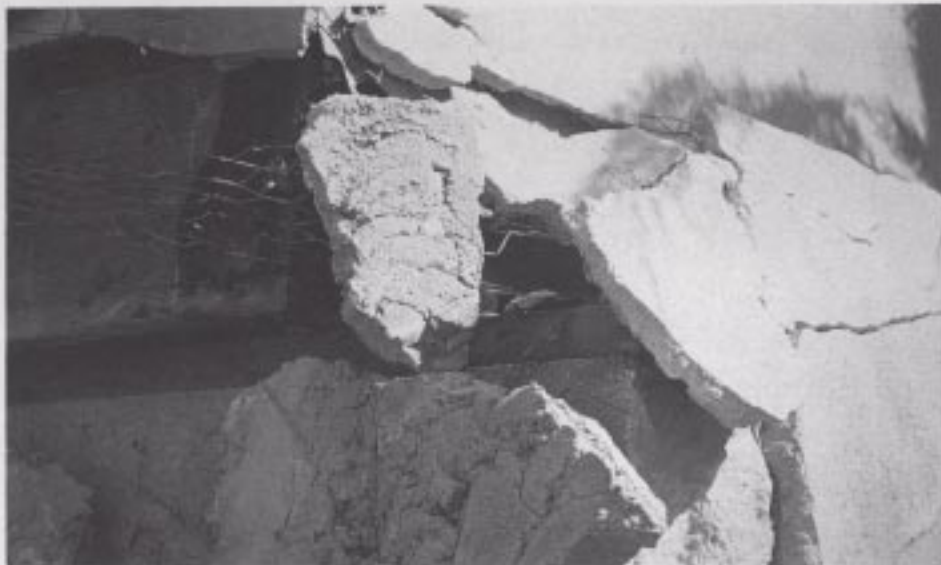
Figure 52. Sliding of floor framing on a crawlspace foundation (concrete stem-wall type) supporting an older MFLR building.

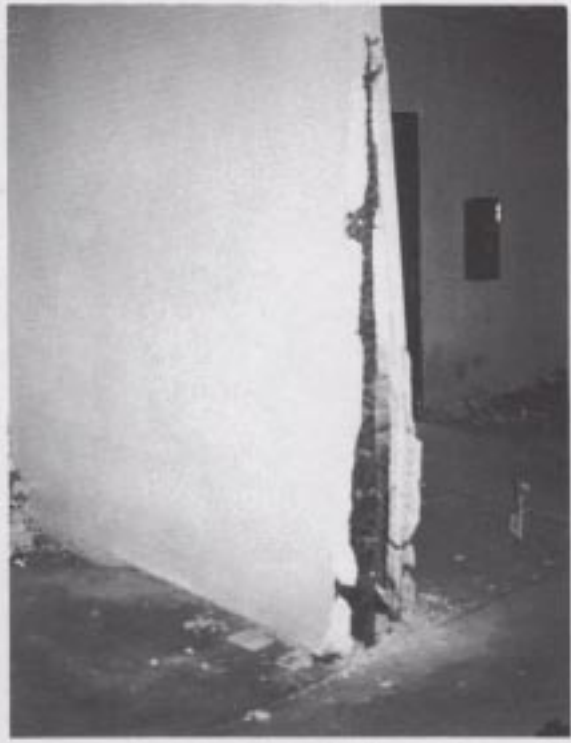
Figure 53. A damaged stucco and wood-frame narrow shear wall located on the first story of an old garden-apartment complex.

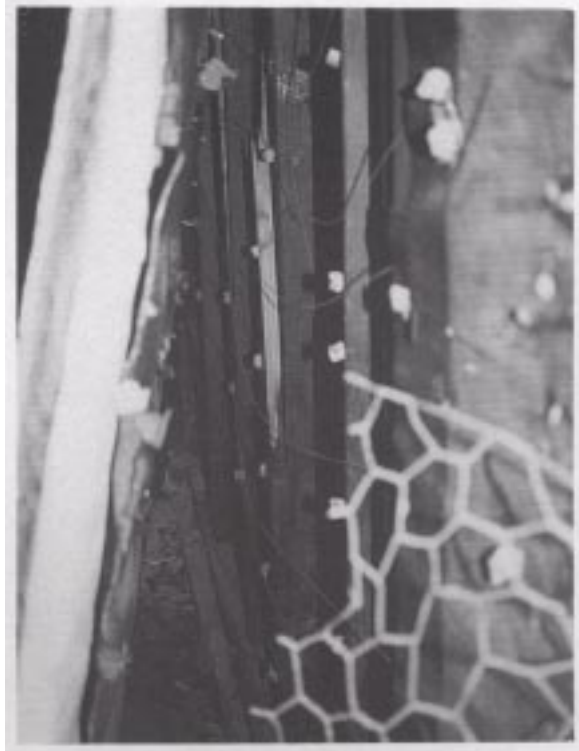
Figure 54. Pulling back the stucco to view longitudinal splitting of studs and stucco adhering to nail heads only inside the shear wall of Figure 53.

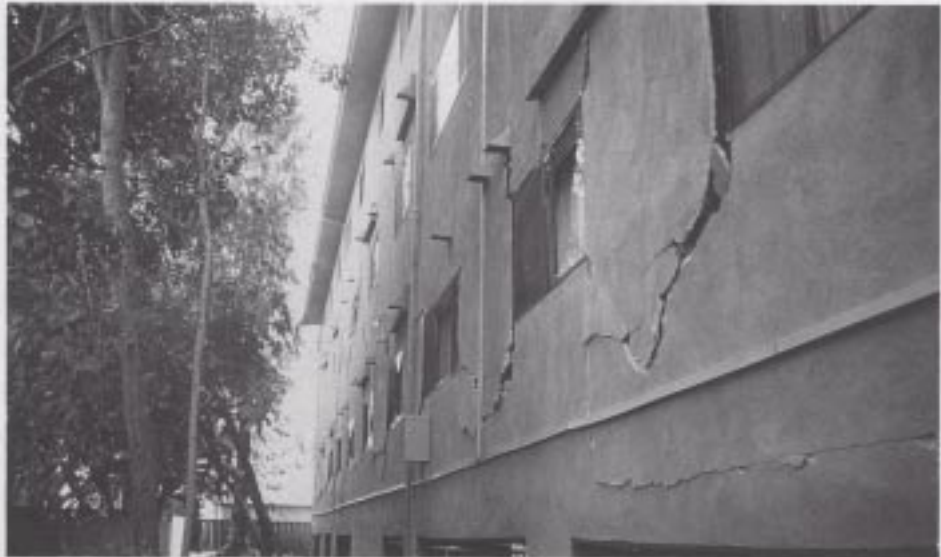
Figure 55. Severe shear cracks in stucco finishes between window openings and along the top of the garage foundation.

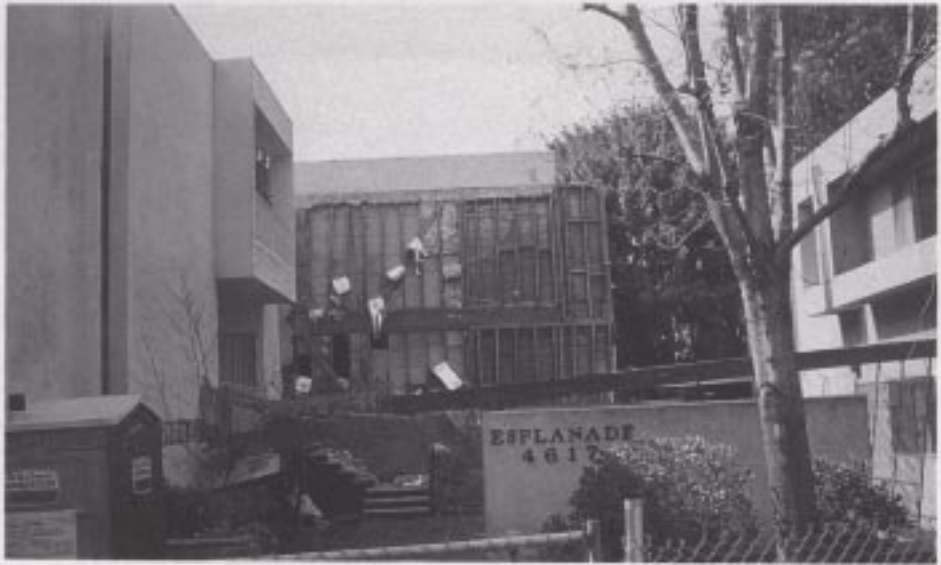
Figure 56. Wholesale loss of stone veneer.

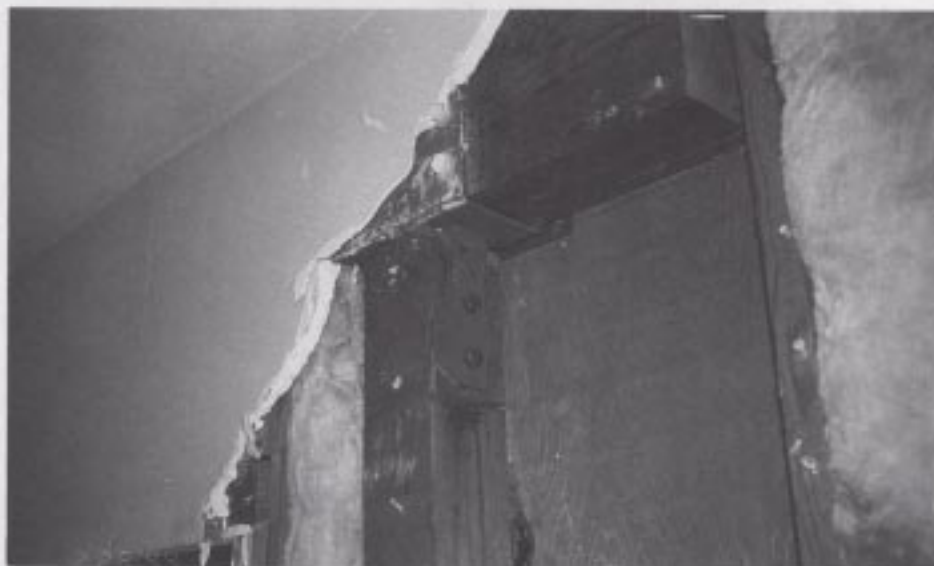
Figure 58. Exposed heavy-timber framing and steel bracket on the first floor showing evidence of a discontinuous connection between the top plate and a header beam.

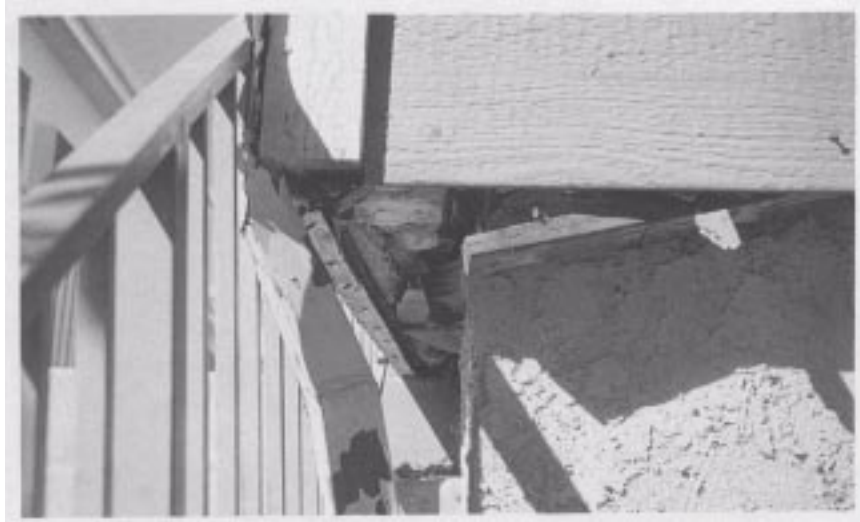
Figure 59. Fractured sill plate and sliding of a new MFLR building on top of an undamaged, reinforced concrete garage foundation.

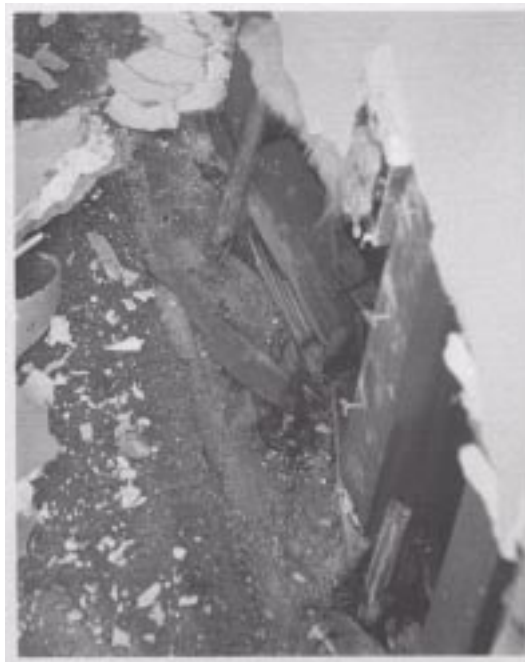
Figure 60. A view inside the building shown in Figure 59 that reveals a missing hold-down bracket, a sheared sill bolt, and a splintered sill plate.
