**Assessment of Damage to
Residential Buildings
Caused by the
Northridge Earthquake**

July 30, 1994

**NAHB Research Center
Upper Marlboro, Maryland**

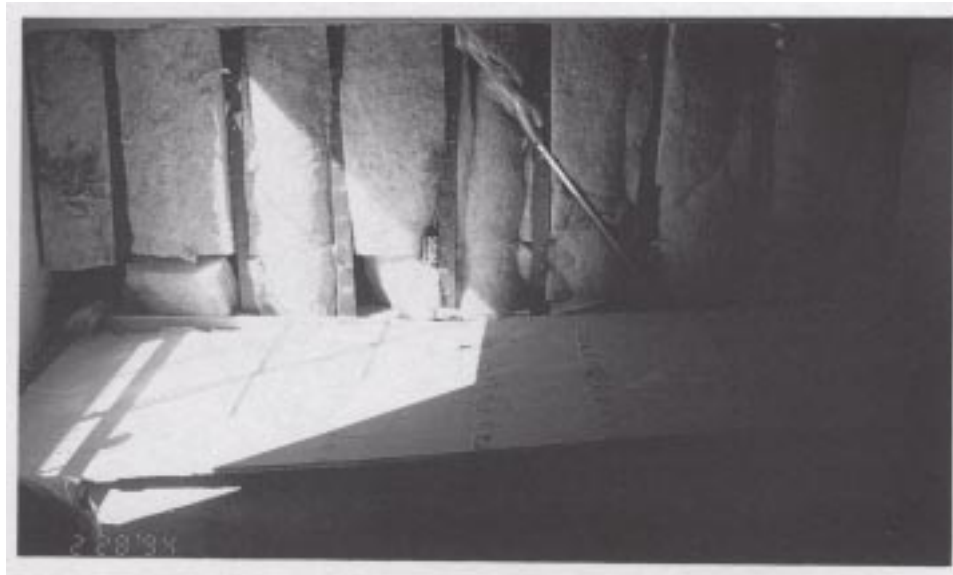
Figure 61. Failed gypsum wall board nailed at 3” on center to provide lateral support to first story of the building on Mammoth Avenue shown in the three previous photographs.

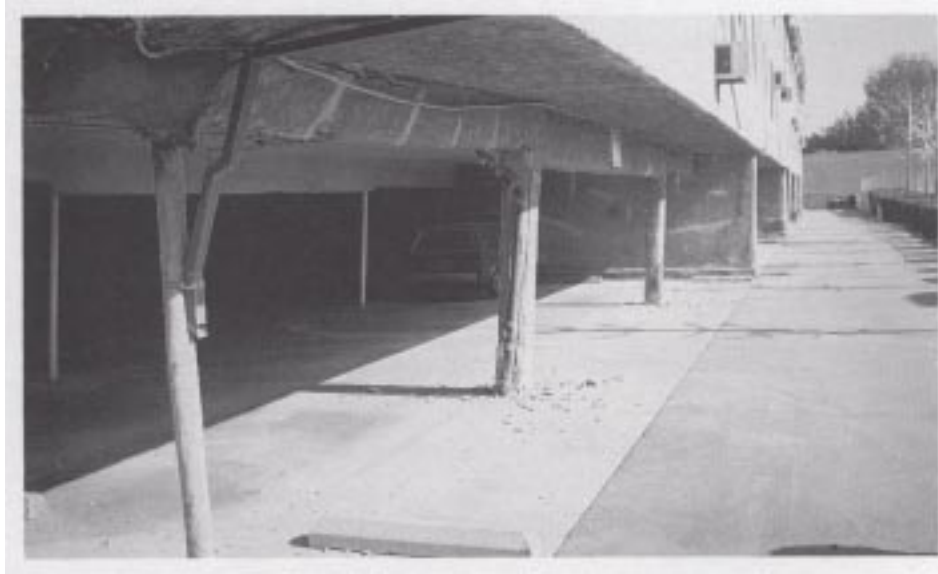
Figure 62. An older soft-story foundation supported by stucco shear walls on one end and steel pipe columns on the other end (near side) creating an imbalance in lateral stiffness.
