**Assessment of Damage to
Residential Buildings
Caused by the
Northridge Earthquake**

July 30, 1994

**NAHB Research Center
Upper Marlboro, Maryland**

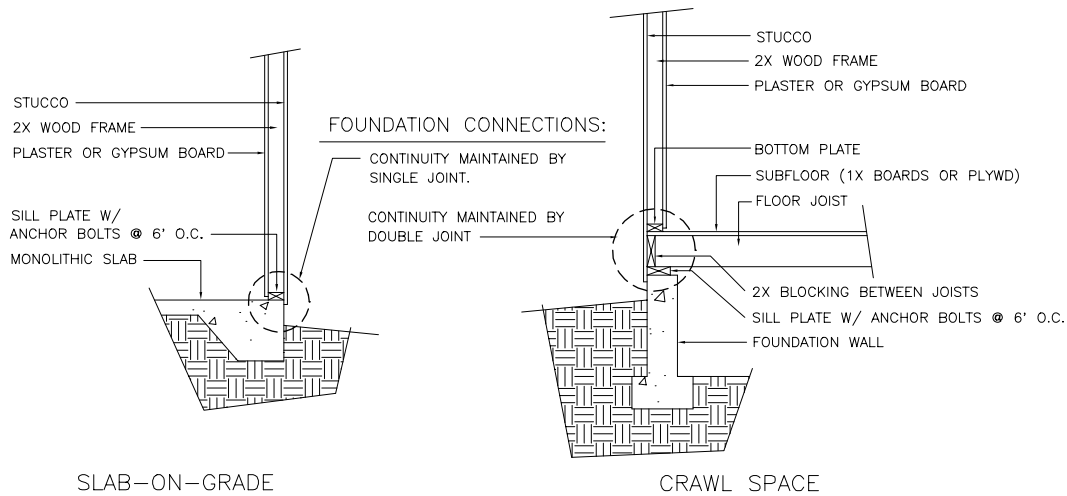
For slab-on-grade homes, the continuity between the wall system and foundation is maintained by a single joint defined by the connection of the sill plate directly to the slab (Figure 16). This connection only needs to transfer the lateral loads imparted by the inertial reaction of the walls, roof, and any upper stories. For crawlspace homes, the connection of the walls to the foundation must also pass through the floor system (Figure 16). This construction requires two joints—one at the sill plate and one at the wall plate—separated by the height of the floor joists. Because this

connection bears the inertial reaction of the first floor and the rest of the above ground structure, the seismic load is greater than for similar homes with slab-on-grade foundations.

In effect, greater flexibility in the foundation connections associated with crawlspace construction by “Type V” prescriptive requirements result in greater deflections during severe ground shaking. Since stucco is brittle, it is sensitive to increases in flexibility of the framing to which it is adhered. As an advantage, this inherent flexibility in the crawlspace construction helps dissipate the transfer of seismic energy or loads to the upper stories of the home which would otherwise create a greater life safety risk for homes on relatively flat sites.

Figure 16 . Detail of the foundation connections for crawlspace and slab-on-grade construction built to the outmoded LA City Type V prescriptive requirements.

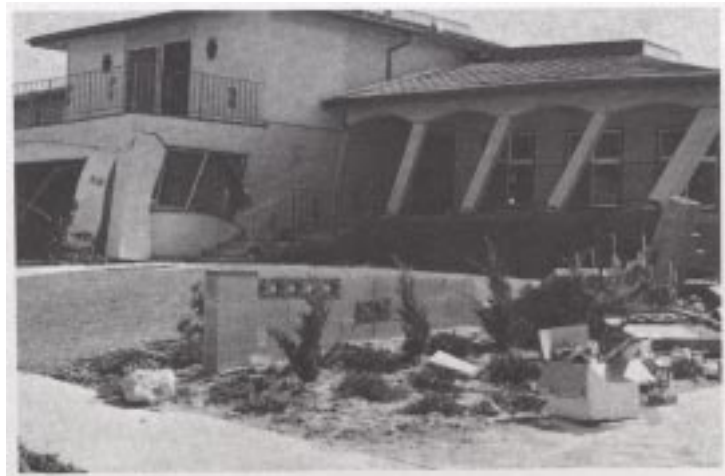
It is well-known that improperly braced foundation cripple walls are highly susceptible to racking as shown in Figure 22 above. While the walls of this home were reinforced following damage from the 1971 (Figure 23) earthquake, the need to reinforce the cripple wall was apparently overlooked (Figure 22). Also, discontinuity in foundation type under this home may have contributed to the damage.

Figure 23. Photograph of the home shown in Figure 22 following the 1971 San Fernando Valley Earthquake (from “Earthquakes-Safety and Survival”, prepared by the Department of Building and Safety, City of LA, Feb. 9, 1971).

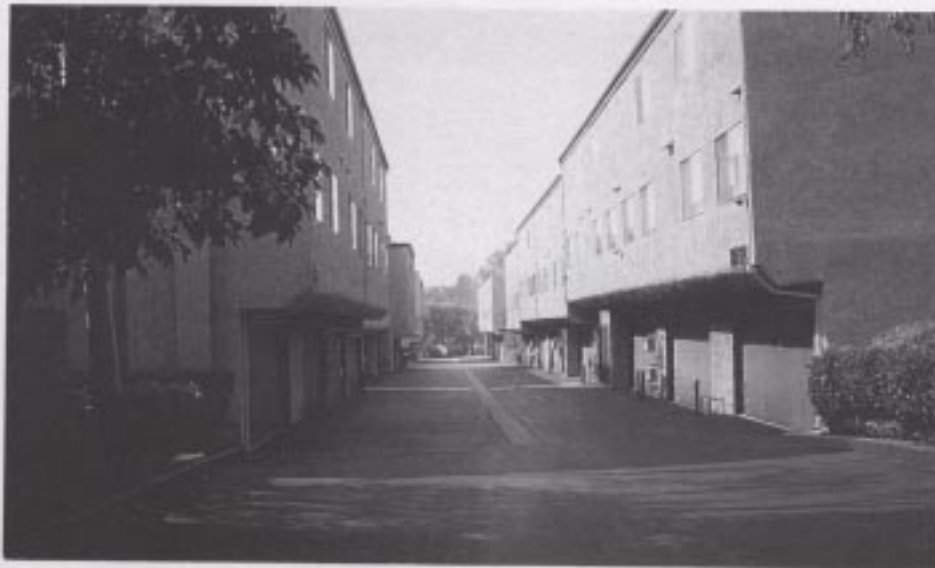
The age of the construction was the primary determinant in the methods and materials used in MFLR/SFA buildings. Prior to the 1970s many MFLR buildings were built on a soft story comprised of open-garage parking underneath of multistory dwelling units. The garage areas or foundations on these older buildings were typically constructed of steel pipe columns, wood-frame shear walls with stucco finish, or a combination of both. The wood-frame garage ceiling or first floor was supported by either steel or engineered wood (e.g., glulam) girders. In some cases, parts of the building were supported on the garage area and also on crawlspace or slab-on-grade foundations. The upper stories of these buildings are constructed using conventional wood-frame practices with let-in bracing and stucco finishes on the exterior (similar to the “Type V” sheet requirements used for SFD construction). The interiors were commonly finished with plaster. The interior and exterior finishes provided an integral contribution to the lateral resistance of these buildings.

Figure 37. An example of a MFLR structure with soft-story garage construction underneath the dwelling units.

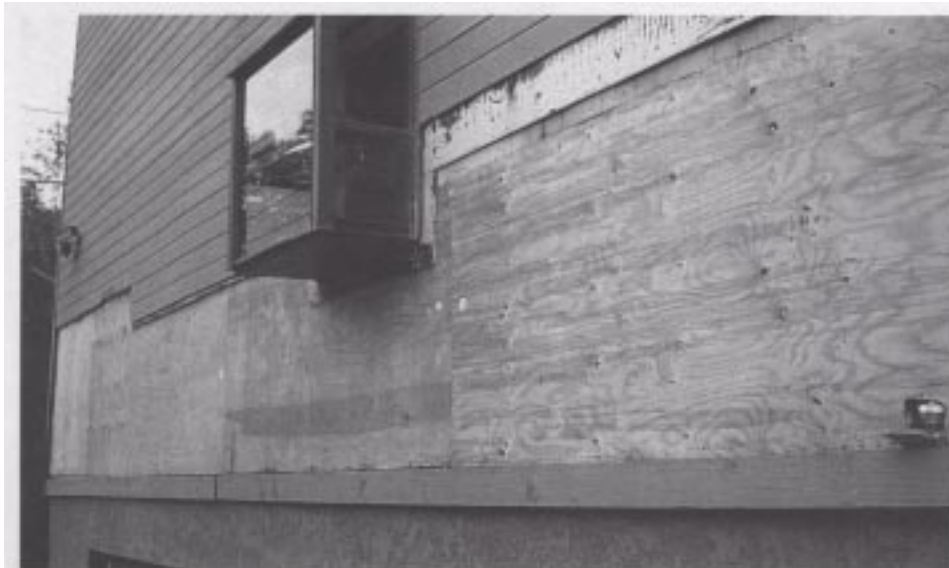
Figure 57. Newer MFLR construction showing the use of plywood sheathing on wood framing.
